NOTICE FOR DOE ARMORERS, SHOOTERS AND RANGE PERSONNEL OPERATING H&K P7 PISTOLS

Prepared by: Dave Ewer, Hanford Patrol Armorer

December 18, 2000

A Hanford Patrol Lesson for Armorers, Range Officers, and SPOs Operating the H&K P7 Pistols.

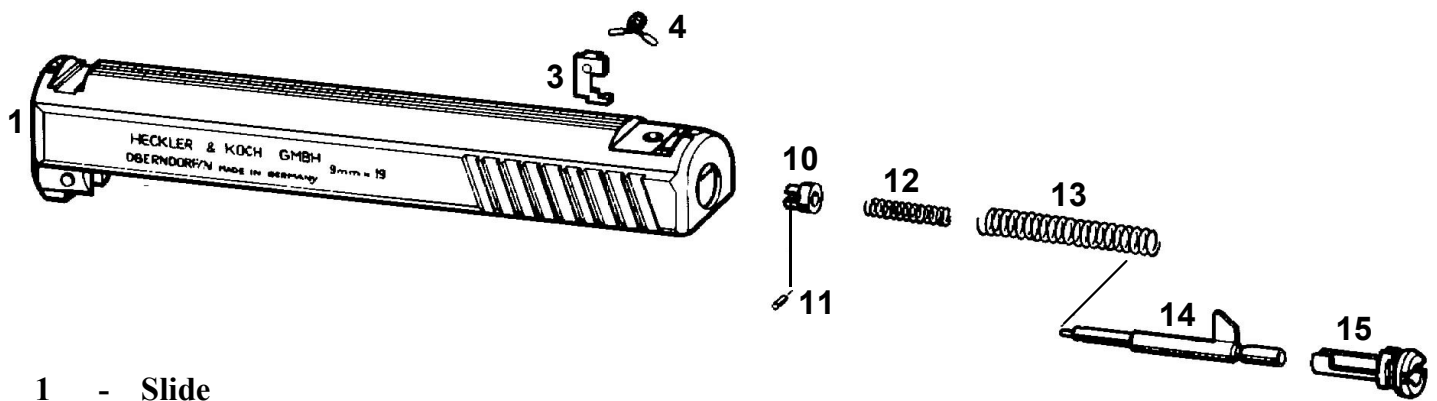
- 1 - Slide
- 3 - Drop Safety Catch
- 4 - Drop Safety Catch Spring
- 10 - Firing Pin Collar
- 11 - Firing Pin Collar Pin
- 12 - Inertia Spring
- 13 - Firing Pin Spring
- 14 - Firing Pin
- 15 - Firing Pin Bushing

This is a detailed diagnosis of two recent H&K model P7 weapons failures involving firing pin problems. Each incident was initiated by abnormal rearward protrusion of the firing pin (Attachments 1 and 2, Item #14). Both incidents were first recognized when the shooter noted the firing pin had appeared to be protruding further rearward from the back of the slide than normal.

mechanical problem associated with this incident turned out to be a sheared Firing Pin Collar-Retaining Pin (Attachments 1 and 2, Item #11) on the front of the firing pin assembly. With this small pin sheared off, there is no base against which the firing pin spring can push to build compression for the firing pin.

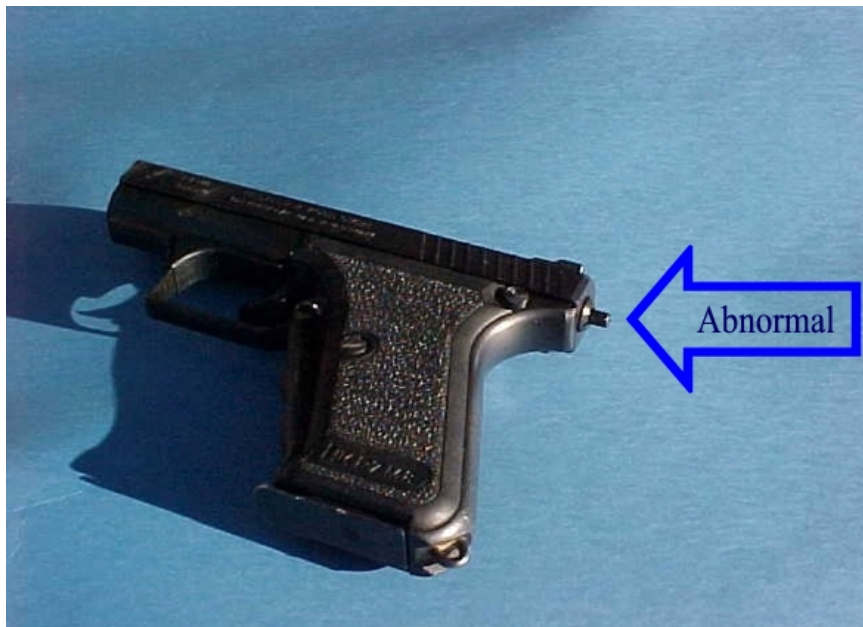
Diagram #3

In the first case, an SPO3 member was firing his P7 when a range officer noticed the firing pin protruding from the rear of the slide nearly twice as far as normal (Attachment 3, Diagram #3). Not understanding why this condition existed, the range officer gave a cease-fire command and had the SPO3 remove the pistol magazine and attempt to clear the weapon. Although the squeeze cocker (Attachment 1, Items #38 and #39) was released, the firing pin remained rearward. When the shooter attempted to move the slide (Attachments 1 and 2, Item #1) rearward to extract the round, the weapon discharged safely downrange. The discharge was due to two broken springs. Both the firing pin spring (Attachments 1 and 2, Item #13) and drop catch safety spring (Attachments 1 and 2, Item #4) had failed. The firing pin spring had separated into two pieces. Three coils had become deeply engaged with the remaining larger portion of the spring causing the firing pin to bind and stick in the rearward position even though still under compression. The recoil from the previous round caused the firing pin to protrude double the normal distance (Attachment 3, Diagrams #2 and #3) out of the back of the slide due in part to the increased operating space brought about by the shortened broken spring. The broken and compressed spring pieces retained enough force to ignite a primer. The Drop Catch Safety Spring also had one of its two arms (Attachments 1 and 2, Item #4) broken and gravity allowed the Catch (Attachments 1 and 2, Item #3) to fall below the path of the firing pin. When the SPO3 grasped the slide to extract the chambered round, the stuck firing pin was dislodged and struck the cartridge primer causing the weapon to discharge safely down range. These two broken springs combined to make this discharge possible. The SPO3 and range officer controlled the weapon and no injuries resulted.

The best possible course of action in these situations on a Firing Range is for the shooter to recognize the abnormal firing pin position and to call a cease-fire, then conduct all further actions under supervision and/or control of the Range Officer, Line Officer, Armorer or other qualified supervisory personnel. These conditions were recognized and acted upon by experienced and trained personnel. Based on experiences described here, others may also be able to recognize these conditions and take actions to preclude any unfortunate accidents. Please disseminate this information accordingly. Feel free to contact Dave Ewer, Hanford Patrol Armorer, on (509) 376-7248 if you have questions or other related experiences.

The key is for the operator to recognize the abnormal condition of the firing pin during operations.
